"LA FENICE" THEATRE - FOYER AND APOLLINEE ROOMS - CONSOLIDATION OF FIRE-DAMAGED STUCCO AND MARMORINO DECORATIONS BY MEANS OF COMBINED APPLICATIONS OF ION-EXCHANGE RESINS AND BARIUM HYDROXIDE

Nicola Berlucchi

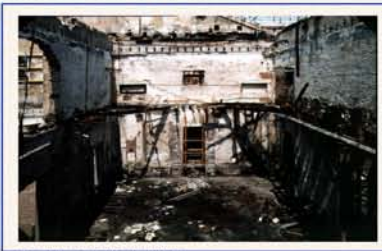
Figure 2 - Same room after devastating fire

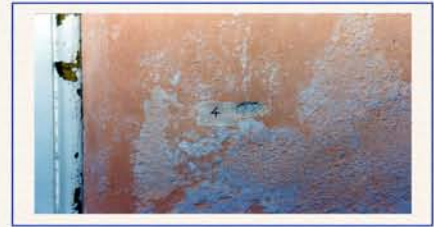
Figure 3 - Detail of marmorino walls at ground floor of Sala Apollinea with deep degradation for saline efflorescence

The fire-damaged decorative elements in the Foyer and the Apollinea rooms mainly consist of plaster and marmorino remains made up of calcium carbonate, and stucco elements made of plaster.
The strong presence of sulphate and chloride salts, not only on the surface but also deep inside the plaster and the walls, is the main cause of chemical deterioration even though such deterioration is closely linked to the presence of water, either from condensation or from capillary action or infiltration, which makes the plaster surface soft to the touch and locally covered with saline efflorescence.
Today, the stucco work is slowly dissolving to form sulphates which penetrate into the walls and the marmorino elements below, causing further deterioration.

Therefore, to improve desalination, it is advisable to carry out a number of treatments using compresses with de-mineralised water and cellulose pulp where possible (marmorino elements) or using ion-exchange resins where it is not wise to use more water (objects in gypsum).

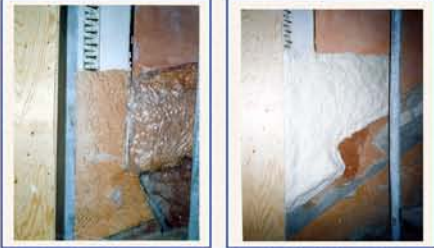
Figures 4-5 - Application of ion-exchange resin after preliminary desalination with de-mineralised water (4) and of paper compress with barium hydroxide (5)

a) first step with absorbent paper compress and de-mineralised water to remove the more soluble excess salts;
b) repeated applications (three times) of de-sulphating ion-exchange resins on the surfaces in order to eliminate the sulphate ion by transforming it into calcium carbonate. This chemical transformation usually (note: this application takes place on the first millimeters of surface and encourages better subsequent penetration of the barium hydroxide, avoiding the formation of barium sulphate, an insoluble salt which also has a whitening effect on the surface);

c) repeated applications of wads and compresses made of cellulose pulp soaked in a 5% solution of barium hydroxide (and/or saturated) in order to transform the sulphate ions present within the material into barium sulphate (an insoluble salt). Excess barium hydroxide is converted into barium carbonate by the CO₂ over a period of time similar to that required for the carbonation of lime.
